Genmega/ Hantle PCI EPP Upgrade Paths

Hyosung PCI EPP Upgrade Paths

Triton PCI EPP Upgrade Paths

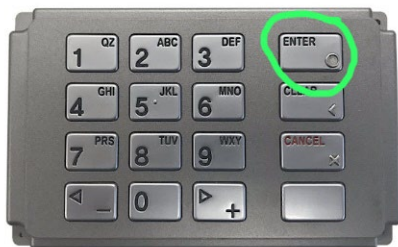
If your keyboard looks like the below photo- with the enter key at the top right it is not compliant. The ATM will need and upgrade/ replacement based off the previous chart.

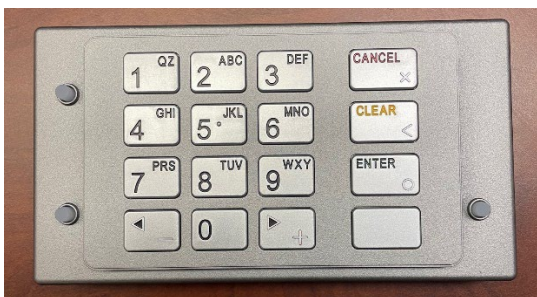
If your keyboard looks like the below photo – with the cancel key at the top right – please look at the backside to ensure it says EPP- B3 or EPP- B5. Pictured below is the compliant EPP-B5.

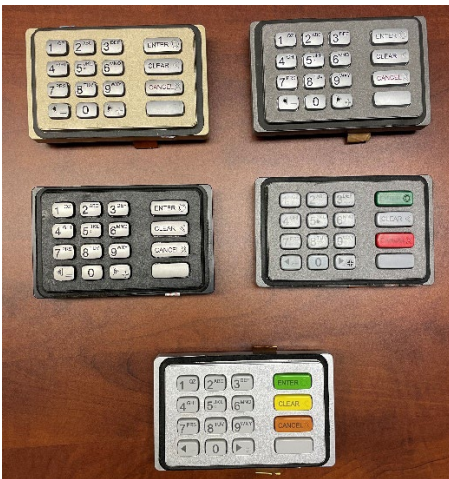
Look at the backside of the Keyboard. If it says 3000K, 5000K, 6000K/R- it is a non compliant keyboard. The ATM will need an upgrade/ replacement based off the previous chart.

If your keyboards look like the below photo- they are not compliant.

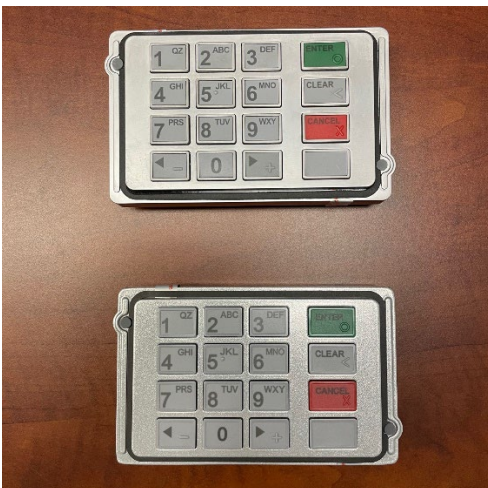
If it says 8000R or X-1, it is a compliant keyboard and will only need a software update.

If your keyboards look like the below photo- they are compliant.

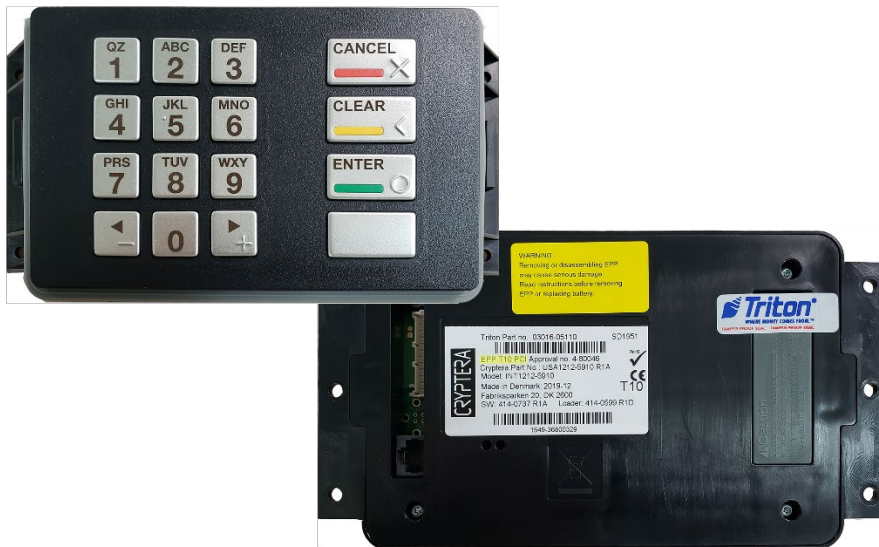
Look at the backside of the Keyboard. If it says anything other than EPP T10 PCI or SW 414-0737 – the keyboard will need to be replaced.

Pictured below is the EPP T10 – which is the only compliant EPP. All others need to be replaced.
